# INFORMATION Nagara River Estuary Barrage

## History of flood control along the Nagara River

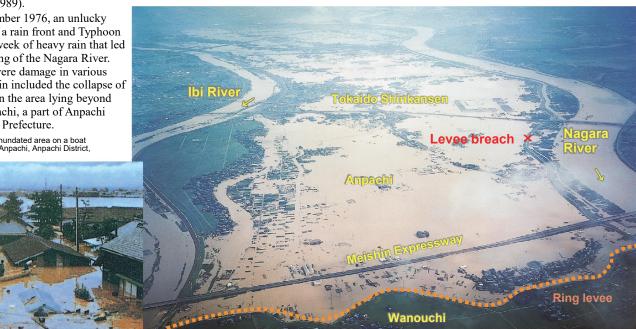
People crossing an inundated area on a boat in September 1976 (Anpachi, Anpachi District Gifu Prefecture)

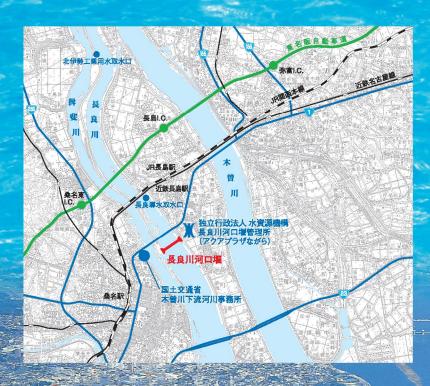
When there is a tsunami warning for the coast of Ise Bay issued by the Japan Meteorological Agency combined with a tsunami height of 2 m or greater measured at the Kamishima gauge station at the mouth of Ise Bay, which signals the advancement of a major tsunami wave from the sea into the estuary, all gates are lifted above the levee height. The gates will therefore not hamper the flow of water.

Once the gates are fully open, a siren will sound or an announcement about an approaching tsunami will be made through speakers to prompt people on boats, fishers, and other river users to evacuate the river. Relevant authorities will be notified of the response too, so patrols will take place to ensure timely evacuation.
